Manhole Inspection Summary

Manhole # S13GG1002MH

Insp Date: **11/11/08 9:05 AM**

Location Address: **4217 PIMLICO RD** Cross Street: **QUANTICO AVE**

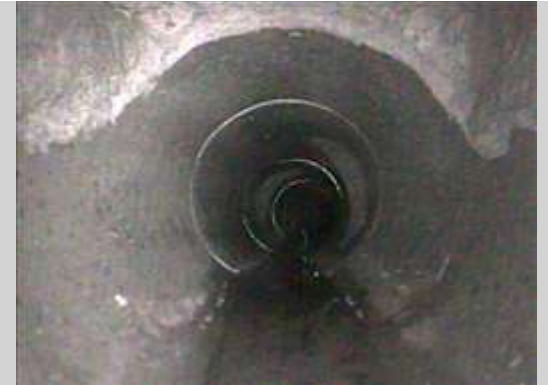
12 O'Clock Outflow

8 in. Circular Gravity Sewer
Pipe Out @ 12 O'Clock

Pipe Height: (in.) Direct
Pipe Material: **Clay** ☐ Pipe Lined
Invert Depth: **8.80** (ft.) Flow Characteristics: **Slow**
Deposits: ☒ None ☐ Mud ☐ Sludge ☐ Debris ☐ Grease
Silt Depth: (in.) Deposits Extent:
Infiltration: **None** Pipe Seal Cond: **Sound**
